HAZARD ALERT

Multi-Piece Rims

Lethal Hazards Part of Rim Repair Work

Accident Summary

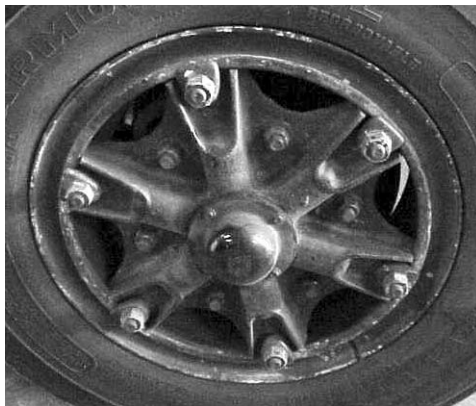
Typical six spoke wheel on a bus.

Close-up of lug nut holding rim to wheel.

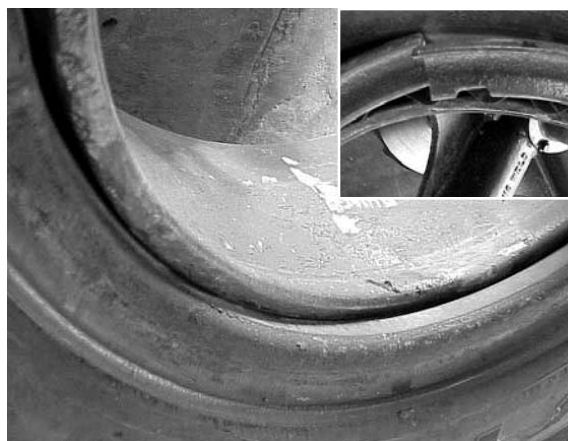
The split side ring markings were illegible because the ring had been painted over with black paint four months earlier. When the paint was scraped off, the split side ring markings showed the ring was mismatched with the rim base and had been damaged when it was mounted previously or had been bent during the accident.

Inner wheel with tire mounted. Inset: Close-up of split rim against mounted tire.

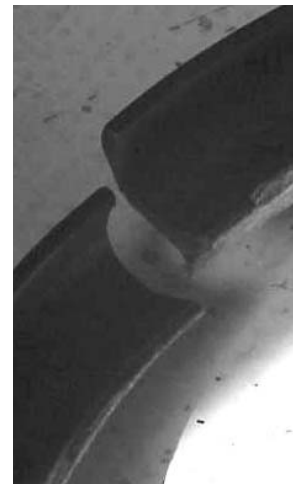
There are several variations of a multi-piece rim, including two-piece and three-piece assemblies. The rim pictured below is a tube-type demountable rim assembly with a split side ring typical of two-piece assemblies.

Close-up of rim at split.

- The split side ring was not completely seated and locked.
- Rim gutters and ring must be free of any surface rust that could obstruct seating of the ring.

When working with multi-piece and single-piece rimmed wheels, **always** use a cage or barrier to protect the worker. There is no greater safety measure than a protective barrier for employees.

If the rim is painted or the markings otherwise illegible, the wheel and tire assembly should not be serviced.
